"A MULTIPLE METHODS APPROACH TO ASSESSING BALLISTIC DAMAGE TO HERITAGE STONE"

The Threat to Heritage Stone

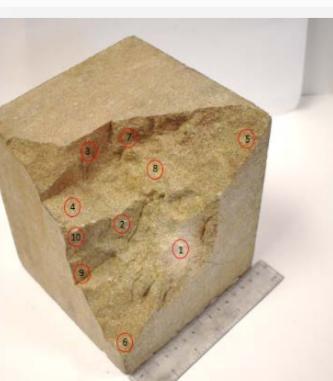
The sampling regime used on the sheared surface

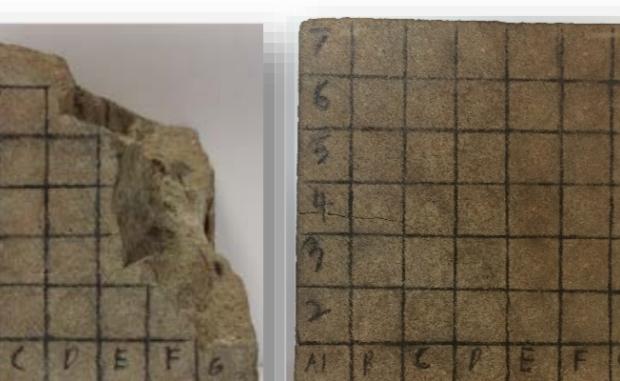
The alpha-numeric cell used for surface surveys

On each of the sides of the sample, an alpha-numeric grid was created to facilitate sampling using permeametry and Equotip rock surface hardness readings. All measurements were conducted 3 times for each cell and averaged.
